Contract #: 04-0120F4Cty: SF/ALA Rte: 80 PM: 13.2/13.9File #: 69.28**WELDING INSPECTION REPORT****Resident Engineer:**Pursell, Gary**Address:** 333 Burma Road**City:** Oakland, CA 94607**Report No:** WIR-013202**Date Inspected:** 10-Feb-2010**Project Name:** SAS Superstructure**OSM Arrival Time:** 7000**Prime Contractor:** American Bridge/Fluor Enterprises, a JV**OSM Departure Time:** 1900**Contractor:** Zhenhua Port Machinery Company, Ltd (ZPMC), Changxing Island **Location:** Shanghai, China**CWI Name:** Zhou zhong hai**CWI Present:** Yes No**Inspected CWI report:** Yes No N/A**Rod Oven in Use:** Yes No N/A**Electrode to specification:** Yes No N/A**Weld Procedures Followed:** Yes No N/A**Qualified Welders:** Yes No N/A**Verified Joint Fit-up:** Yes No N/A**Approved Drawings:** Yes No N/A**Approved WPS:** Yes No N/A**Delayed / Cancelled:** Yes No N/A**Bridge No:** 34-0006**Component:** OBG Components**Summary of Items Observed:**

Caltrans Quality Assurance (QA) Inspectors performed random visual inspection of OBG segment 7DW internal floor beam, Deck panel, Corner assemblies and deck panel diaphragms surfaces from the panel point 56 to 55.5 after grit blasting. Areas that marked

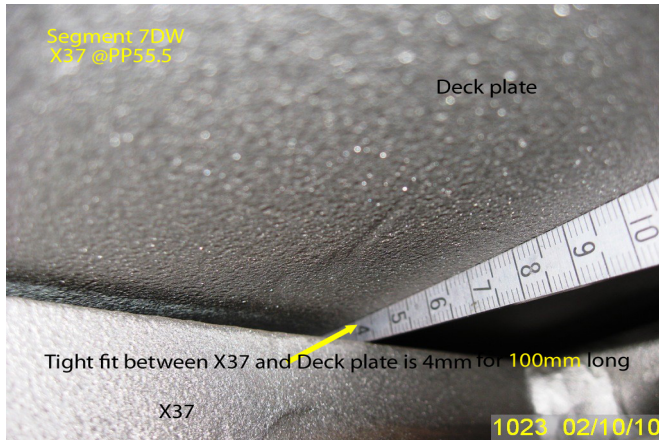
X37 plates welded with Deck plate at PP55.5 the weld no is identified as SEG039E-076,077

The gap between X37 to deck plate was 4mm observed for approximately 100mm. this is added in punch list for ZPMC future repair.
